PUBLIC ROADS

A JOURNAL OF HIGHWAY RESEARCH

SEPTEMBER, 1926

THIN BRICK PAVEMENTS STUDIED

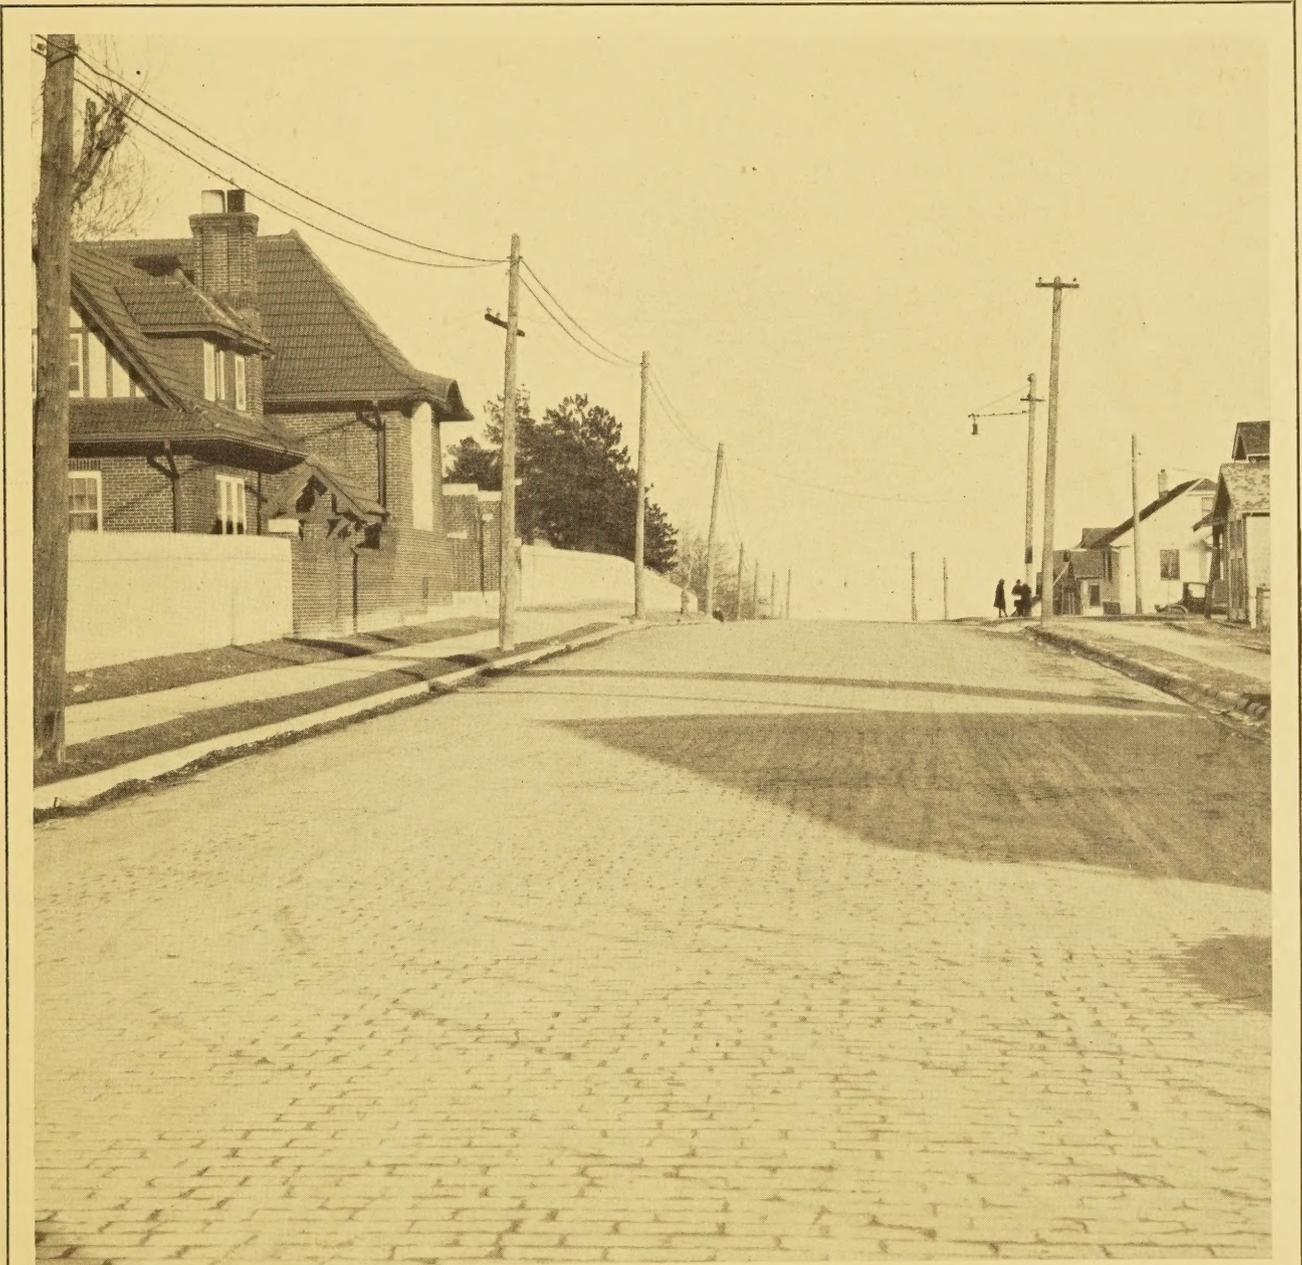
PARKER STREET, OMAHA, IN FEBRUARY, 1926. PAVED IN 1915 WITH 2½-INCH BRICK ON A 5-INCH CONCRETE BASE

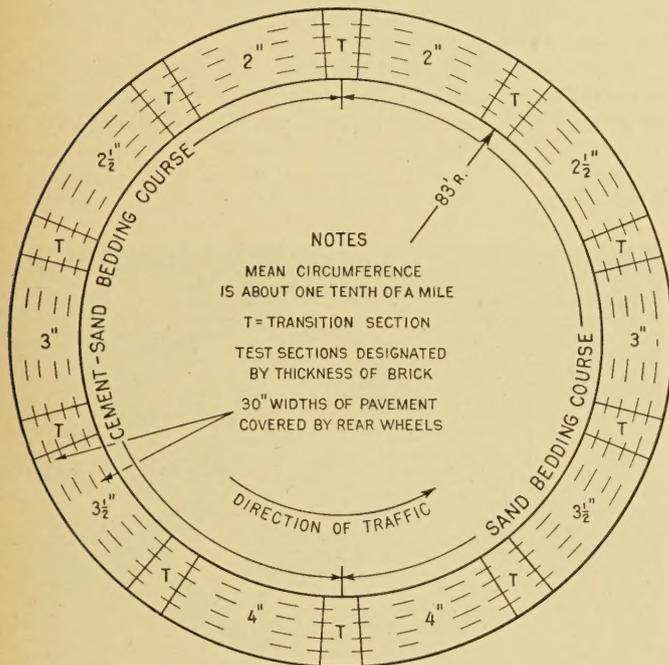
FIG. 1.—GENERAL PLAN OF BRICK TEST TRACK

A circular concrete base, which formerly had served in tests of bituminous pavements, was available and was used as a base for the brick sections. This base has a mean circumference of about 540 feet, is 13 feet wide, and at the beginning of these tests was in perfect condition.

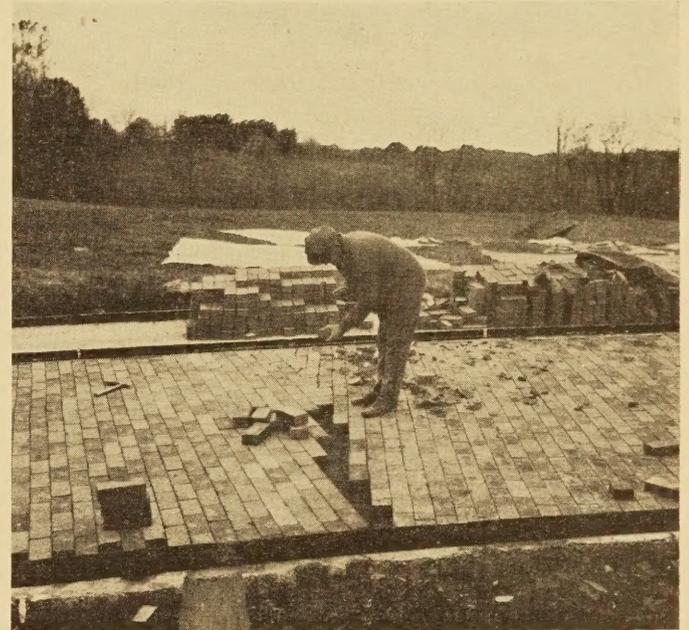
FIG. 2.—BRICKLAYER CLOSING IN A "DUTCHMAN." THIS FEATURE WAS NECESSARY TO COMPENSATE FOR THE CURVATURE OF THE TEST TRACK

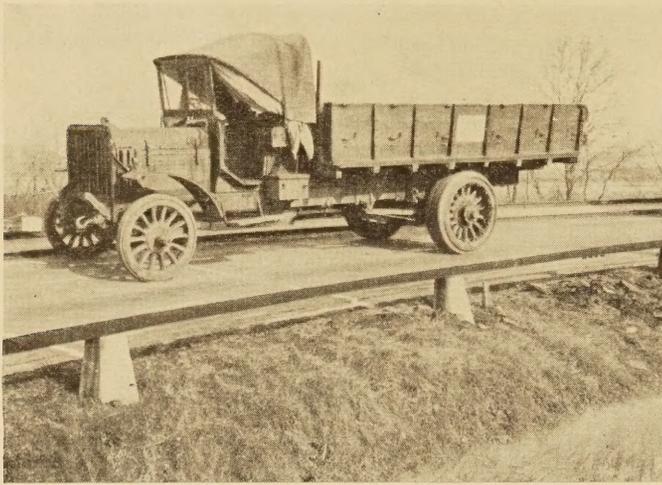
FIG. 3.—TYPE OF TRUCK AND SOLID RUBBER TIRES USED DURING THE FIRST PHASE OF THE TEST

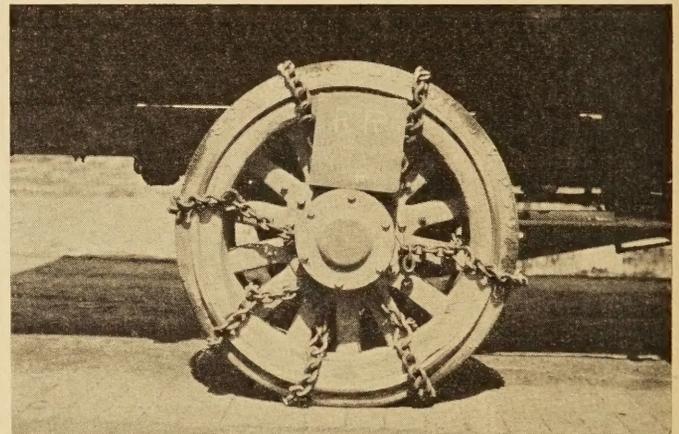
FIG. 4.—TRUCK WHEEL EQUIPPED WITH NONSKID CHAINS DURING THE SECOND PHASE OF THE TRAFFIC TEST

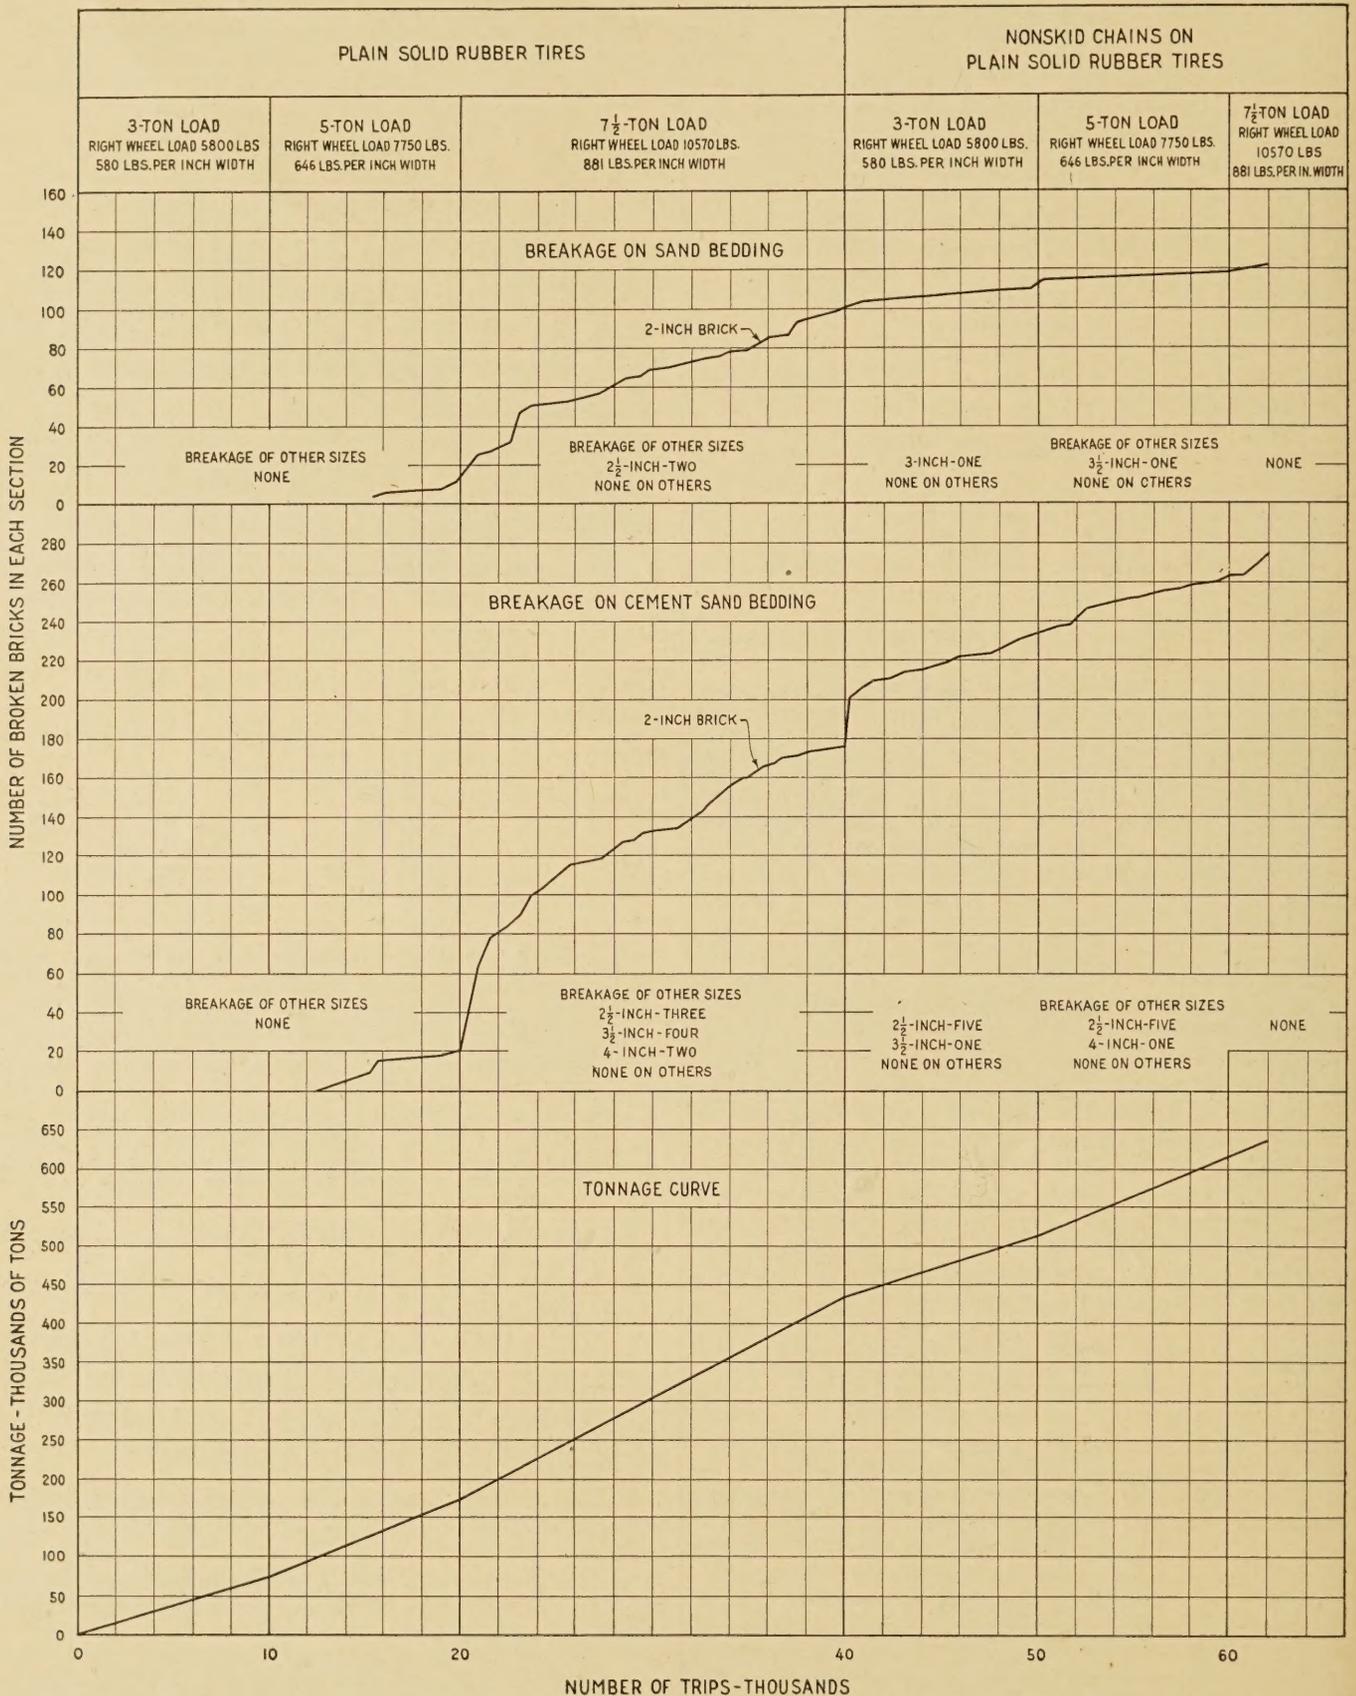
FIG. 5.—RESULTS OF THE ACCELERATED TRAFFIC TEST AS MEASURED BY THE NUMBER OF BRICK IN THE 30-INCH WHEEL STRIPS OF EACH SECTION, BROKEN TRANSVERSELY UNDER EACH LOAD IN THE TWO PHASES OF THE TEST; AND CURVE SHOWING THE TONNAGE TO WHICH THE BRICK WERE SUBJECTED

The results of the accelerated traffic test as measured by the percentage of the total number of brick in the two 30-inch wheel strips of each section, broken transversely under each load in the two phases of the test, are shown in Table 2. The same data expressed in numbers of broken brick, graphically for the 2-inch brick and in tabular form for the other thicknesses, are shown in Figure 5. These are the data from the traffic test. The results of the physical tests of the brick and the compression tests made on brick taken from the pavement after the completion of the traffic tests are shown in Tables 3 and 4, respectively.

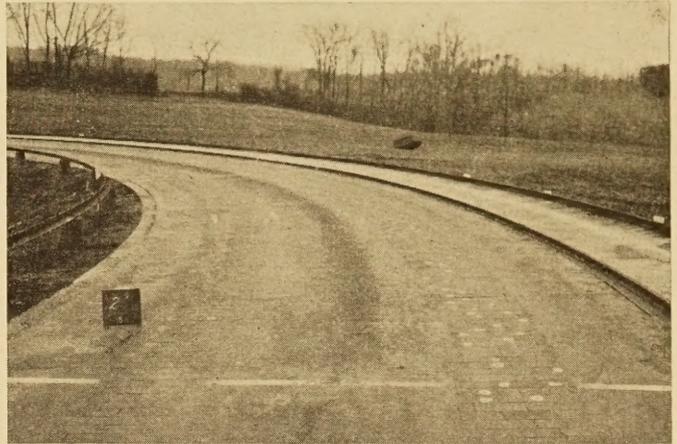
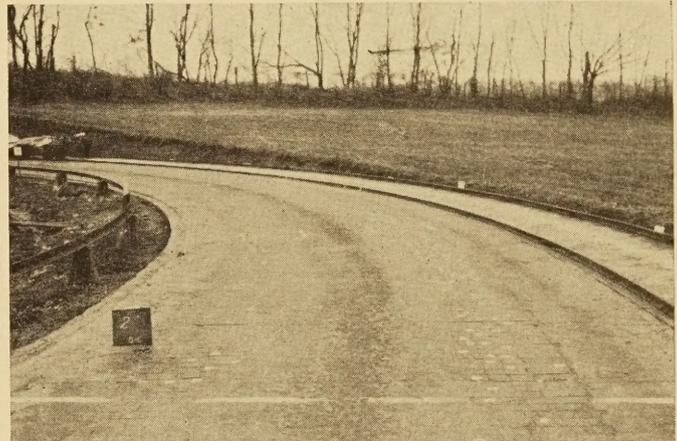
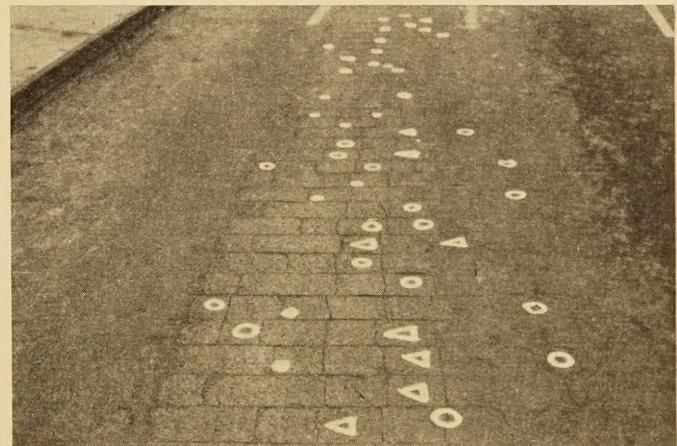
2-INCH BRICK ON SAND BEDDING

2-INCH BRICK ON SAND-CEMENT BEDDING

CLOSE-UP VIEW OF 2-INCH BRICK ON SAND-CEMENT BEDDING

FIG. 6.—CONDITION OF THE 2-INCH BRICK SURFACE AFTER THE COMPLETION OF THE PLAIN-SOLID-TIRED TRAFFIC. BROKEN BRICK ARE MARKED WITH WHITE PAINTED SYMBOLS THE SHAPE OF WHICH INDICATES THE AMOUNT OF TRAFFIC WHICH HAS PASSED OVER THE SECTION UP TO THE TIME THE BREAK OCCURRED. FOR EXPLANATION OF SYMBOLS SEE TABLE 4

Figures 6 to 10, inclusive, show the condition of the several brick sections at the completion of the plain-solid-tired traffic; and it will be observed that the damage in all sections was practically limited to transverse breakage. Practically all the cobbling resulted from the operation of the traffic equipped with nonskid chains, and the greater part occurred during the early stages of this traffic. It seemed that after the corners

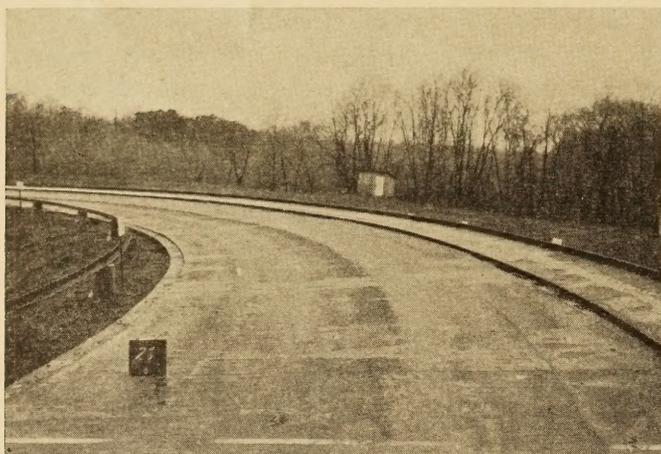
FIG. 7.—CONDITION OF THE 2½-INCH BRICK SECTION LAID ON SAND BEDDING AFTER COMPLETION OF THE PLAIN-SOLID-TIRED TRAFFIC

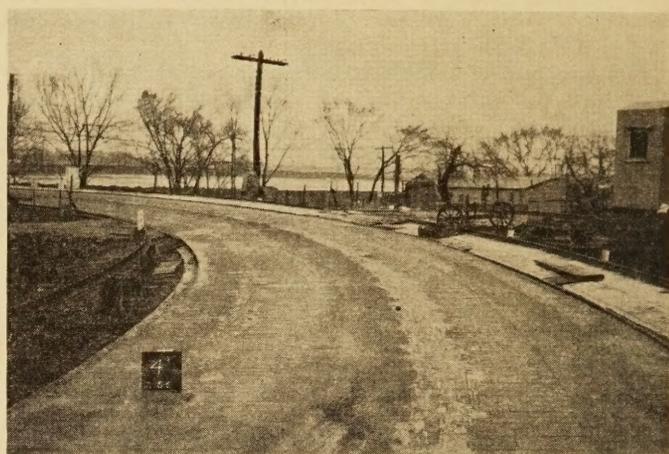
FIG. 10.—CONDITION OF THE 4-INCH BRICK SECTION. IN THIS CASE ALSO THERE WAS NO APPARENT DIFFERENCE BETWEEN THE SECTIONS ON THE TWO BEDDING COURSES

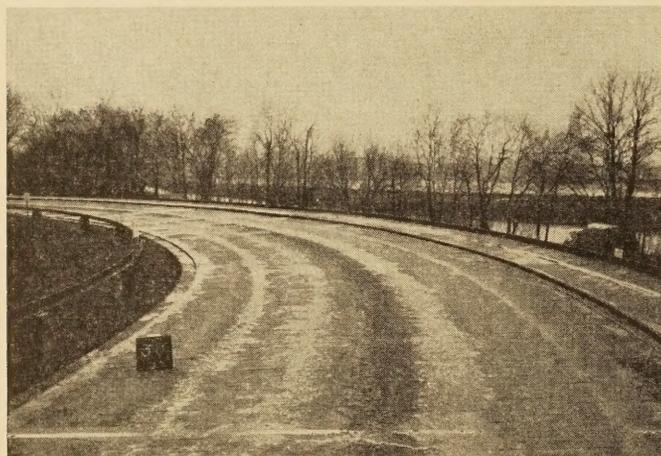
FIG. 8.—CONDITION OF THE 3-INCH BRICK SECTION AFTER COMPLETION OF THE PLAIN-SOLID-TIRED TRAFFIC. THERE WAS NO APPARENT DIFFERENCE BETWEEN THE SECTIONS ON SAND AND CEMENT-SAND BEDDING COURSES

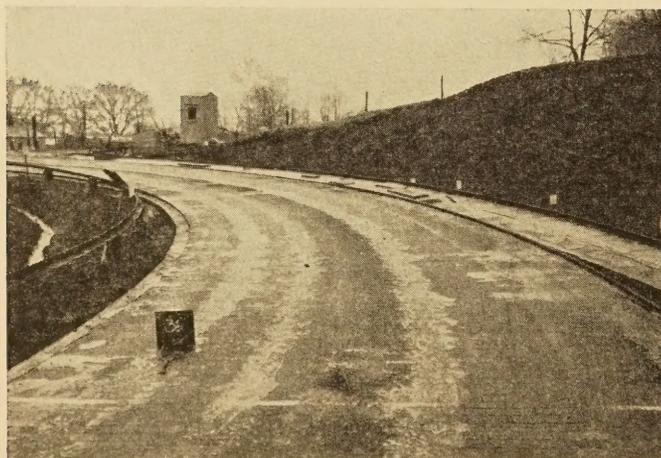
FIG. 9.—CONDITION OF THE 3½-INCH BRICK SECTION AFTER COMPLETION OF THE PLAIN-SOLID-TIRED TRAFFIC. THERE WAS NO APPARENT DIFFERENCE IN THE SECTIONS LAID ON THE TWO BEDDING COURSES

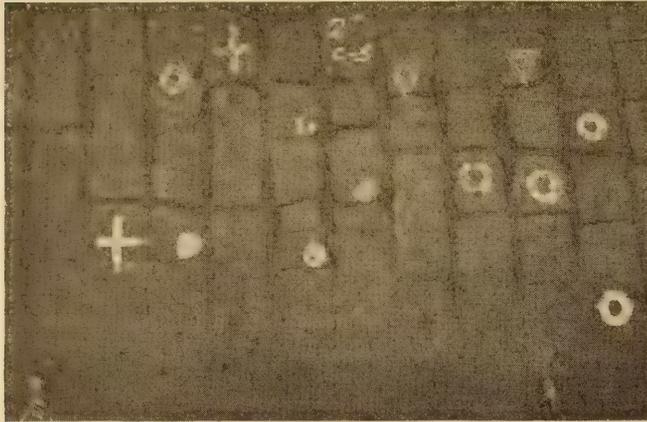
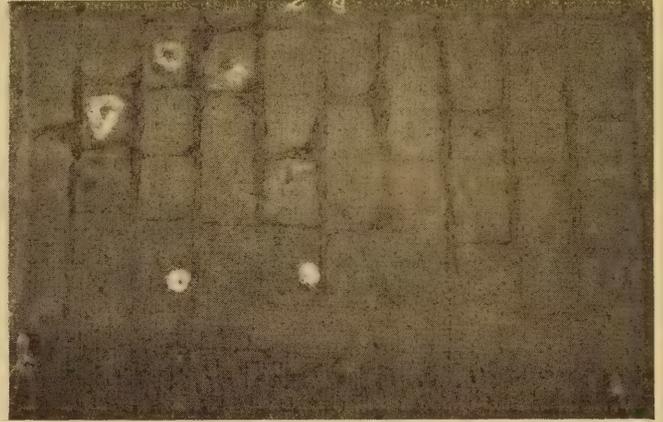
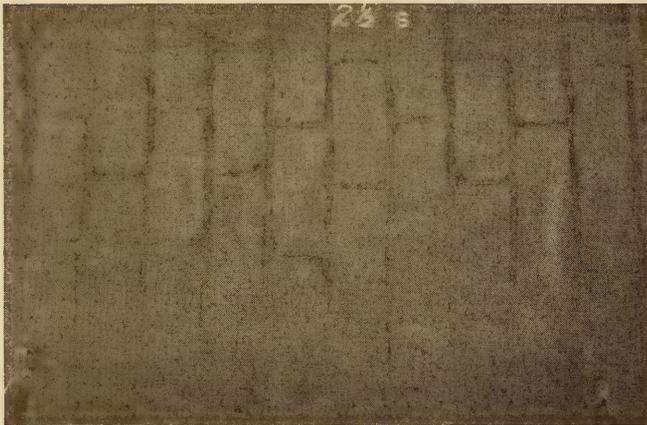
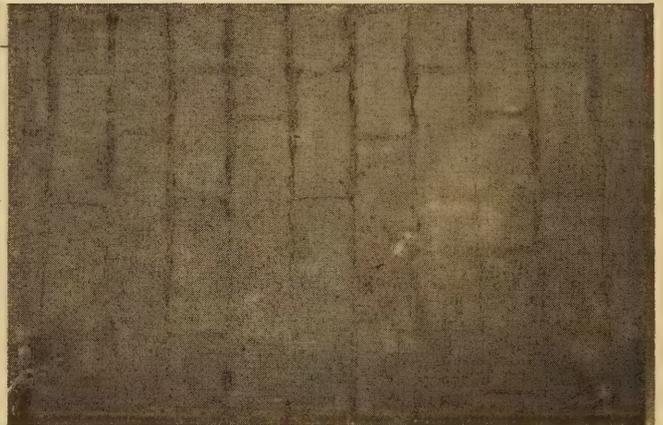
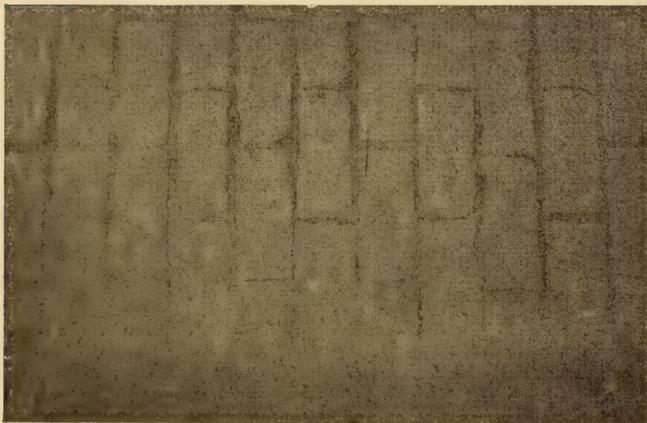
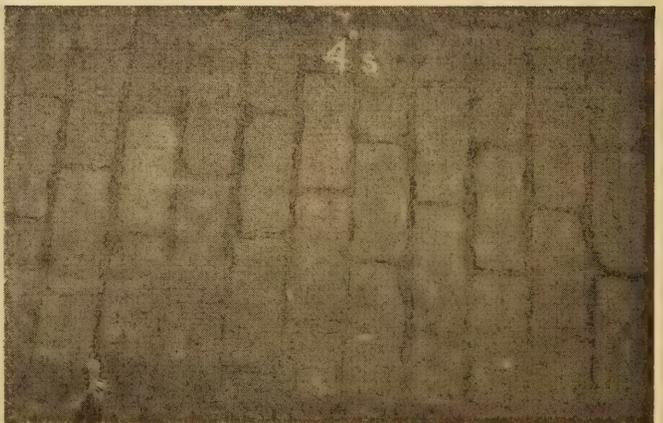
FIG. 11.—LOOKING DOWN ON THE SEVERAL SECTIONS AFTER COMPLETION OF THE CHAIN-EQUIPPED TRAFFIC. NONE BUT THE 2-INCH BRICK SHOWED SUFFICIENT BREAKAGE TO JUSTIFY A CONCLUSION AS TO THE EFFECT OF THE TYPE OF BEDDING. FOR EXPLANATION OF SYMBOLS SEE TABLE 4

The condition of the brick in the several sections after the completion of the chain-equipped traffic is shown in Figures 11, 12, and 13. It will be noted that very little difference is apparent between the condition of the 2½, 3, 3½, and 4 inch brick sections, all being in almost perfect condition at the completion of the traffic test. The sections of 2-inch brick, on the other hand, show marked effects of the heavy traffic.

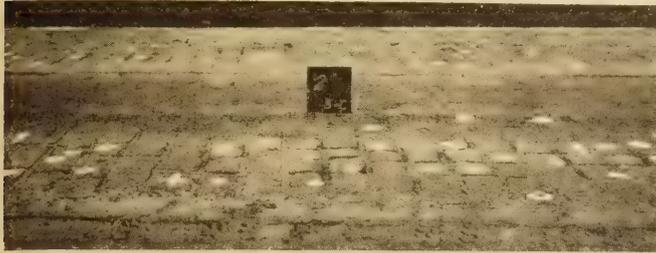
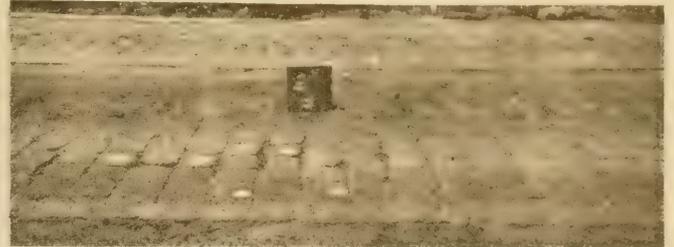
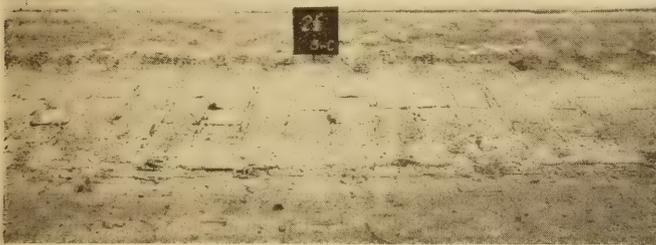
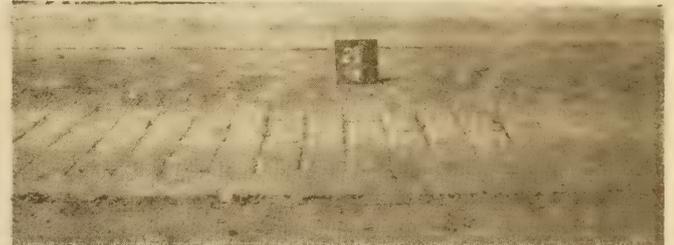
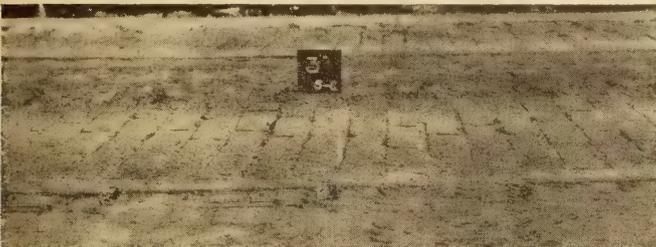
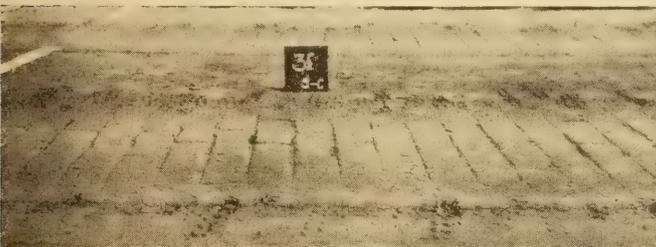
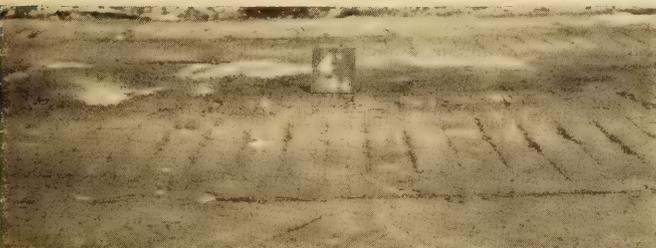
FIG. 12.—LOOKING ACROSS THE SEVERAL SECTIONS AFTER COMPLETION OF THE CHAIN-TIRED TRAFFIC, SHOWING THE BREAK-AGE AND DEGREE OF COBBLING

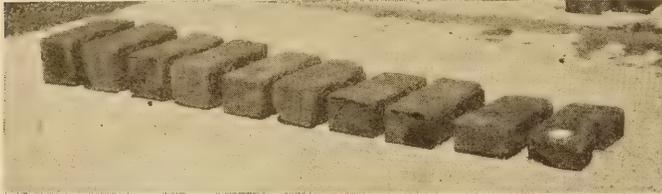
FIG. 13.—BRICK OF THE DIFFERENT SIZES TAKEN FROM THE TEST PAVEMENT AFTER TRAFFIC. THE GROUP SHOWS THE EXTREME VARIATIONS IN THE CONDITION OF THE BRICK AFTER THE SERVICE TESTS

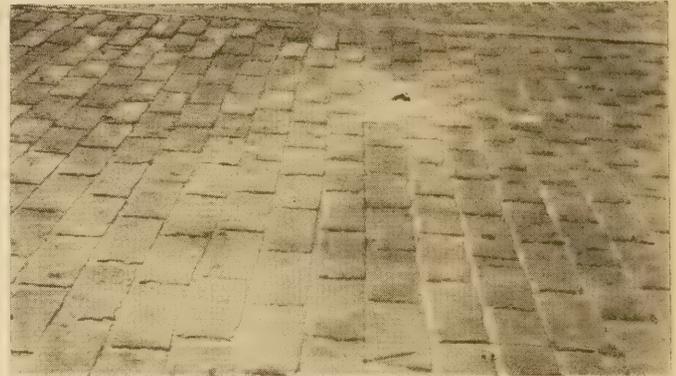
FIG. 14.—MAIN STREET, GREENVILLE, TEX. DETAIL VIEW OF THE $2\frac{1}{4}$ -INCH REPPRESSED BRICK SURFACE LAID 1905-06

This pavement has had heavy traffic, a large amount of which has been in steel-tired vehicles. Very little breaking, rounding, or cobbling has taken place, the pavement being in excellent condition except at a few places where breaks in the base have occurred (fig. 14).

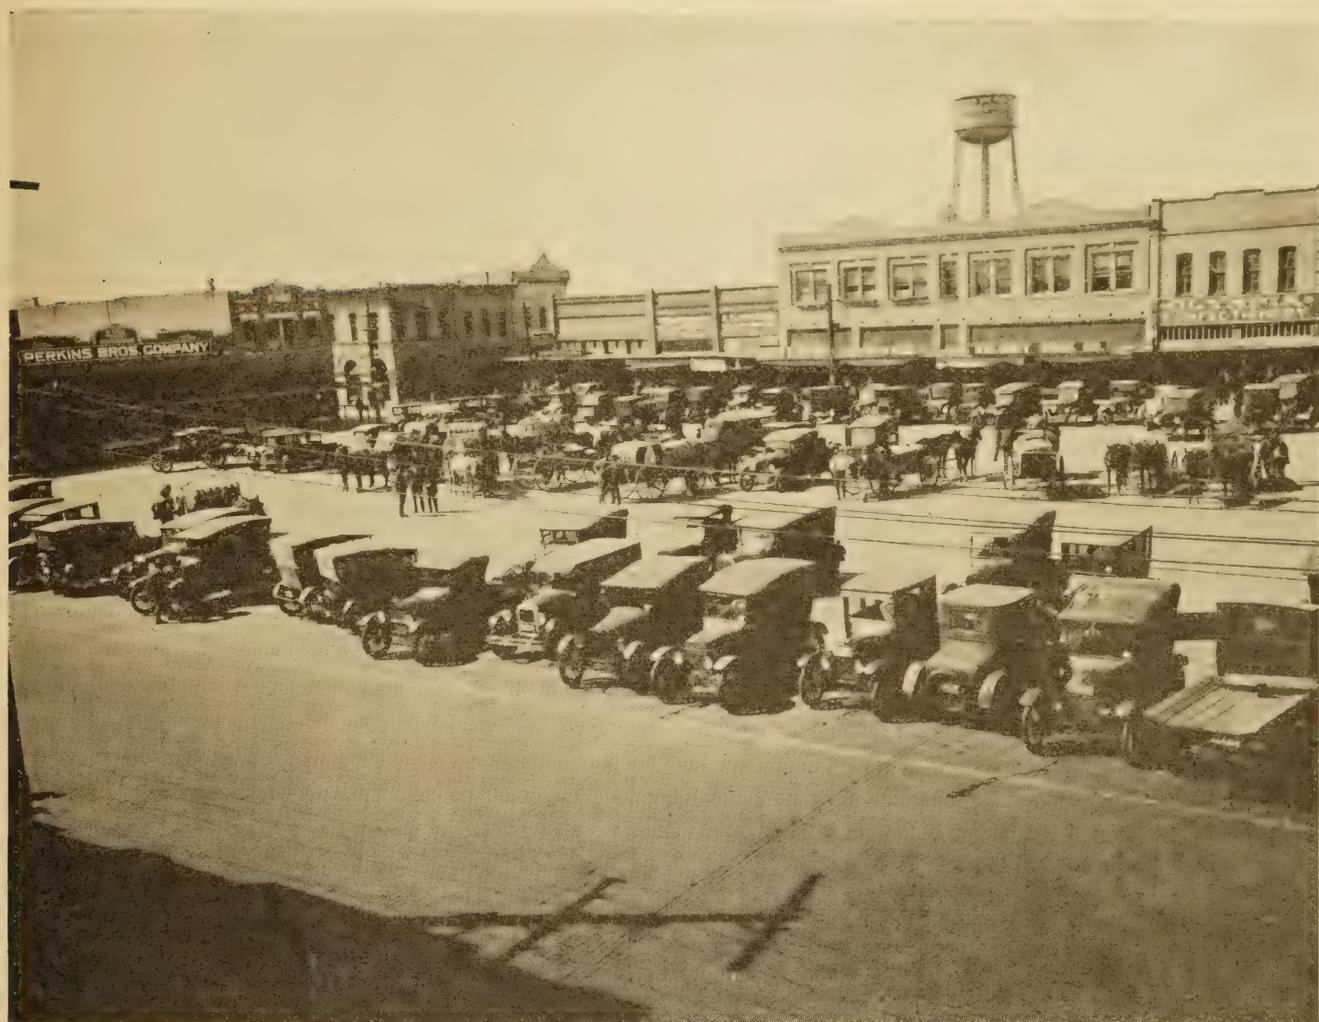
FIG. 15.—PUBLIC SQUARE, SULPHUR SPRINGS, TEX. TWO AND ONE-HALF-INCH BRICK LAID IN 1915 ON A 4-INCH CONCRETE BASE WITH 1-INCH SAND BEDDING AND ASPHALT FILLER

Sulphur Springs, Tex.—Better subgrade conditions than at Greenville. Paved streets carry traffic occasioned by surrounding rich agricultural area (fig. 15).

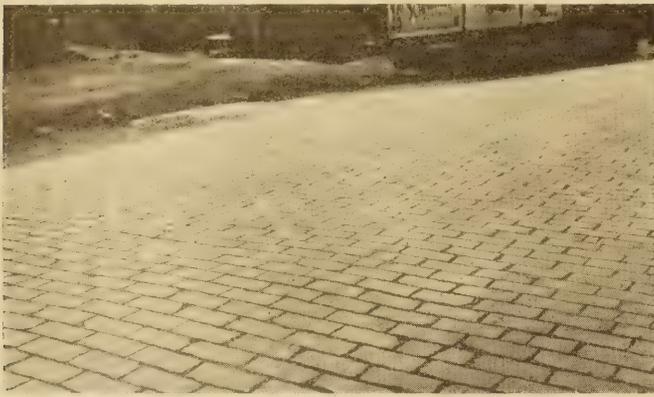
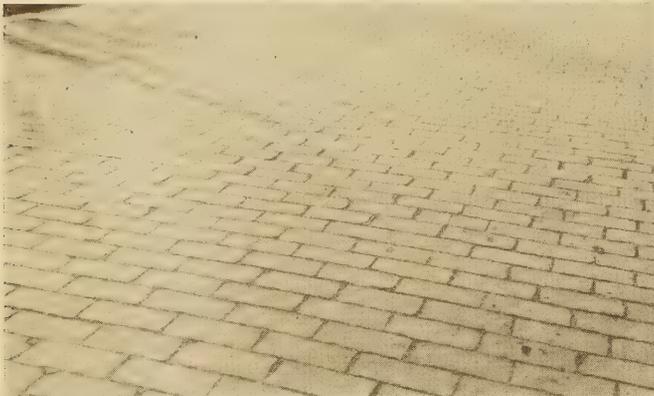
MAIN STREET— $2\frac{1}{2}$ -INCH BRICK ON A 5-INCH CONCRETE BASE, 1-INCH SAND BEDDING AND ASPHALT FILLER

RESIDENTIAL STREET— $2\frac{1}{2}$ -INCH BRICK ON A 4-INCH CONCRETE BASE, 1-INCH SAND BEDDING AND ASPHALT FILLER

FIG. 16.—CONDITION OF BRICK LAID AT TEMPLE, TEX., IN 1915 ON MAIN STREET AND A RESIDENTIAL STREET

Approximately 40,000 square yards of $2\frac{1}{2}$ -inch brick were laid on Main and other streets during 1915. The construction was as follows: 4 to 5 inches of concrete (1:8 pit-run gravel) base, 1-inch sand bedding and asphalt filler. The condition of these pavements at the time of the inspection was good, although some failures had occurred in the bases apparently from bad subgrade conditions (fig. 16).

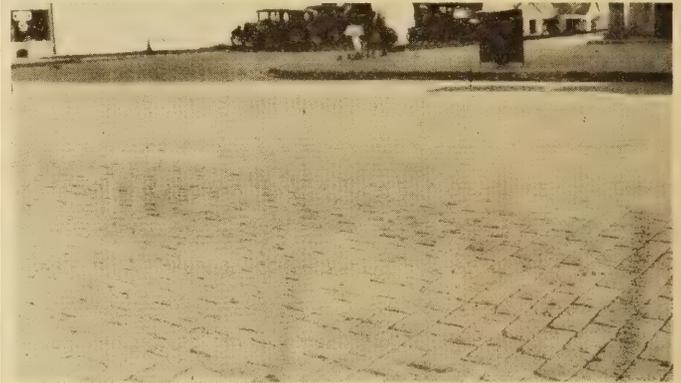
FIG. 17.—DETAIL VIEW SHOWING CONDITION IN FEBRUARY, 1926, OF THE $2\frac{1}{2}$ -INCH BRICK LAID AT OKEEMAH, OKLA., IN 1920 ON A 5-INCH CONCRETE BASE WITH GROUT FILLER

filler on a portion of Main Street and asphalt on the other pavements. These streets were in nearly perfect condition when inspected in February 1926 (fig. 17).

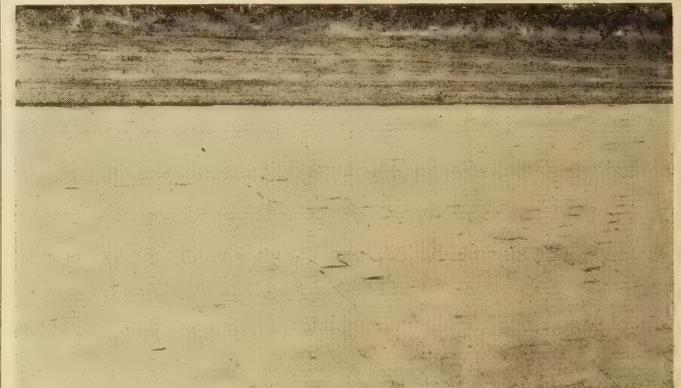
FIG. 18.—DETAIL VIEW OF THE CONDITION IN FEBRUARY, 1926, OF THE $2\frac{1}{2}$ -INCH BRICK LAID ON THE MAIN APPROACH TO OKLAHOMA CITY. THE BRICK WERE LAID IN 1918 ON A 4-INCH (1:3:6) CONCRETE BASE AND $1\frac{1}{2}$ -INCH SAND BEDDING WITH ASPHALT FILLER

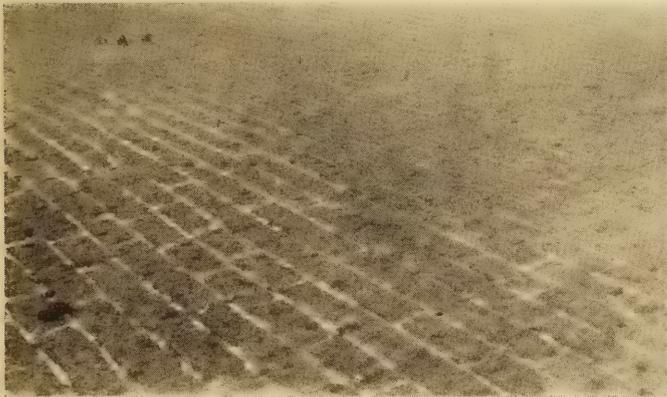
FIG. 19.—DETAIL VIEW OF $2\frac{1}{2}$ -INCH BRICK LAID DURING 1919 ON MAIN STREET, TONKAWA, OKLA. THE PHOTOGRAPH SHOWS THE CONDITION OF THIS PAVEMENT IN FEBRUARY, 1926. IT WAS LAID ON A 4-INCH MORTAR (1:4) BASE AND $1\frac{1}{2}$ -INCH SAND BEDDING WITH GROUT FILLER

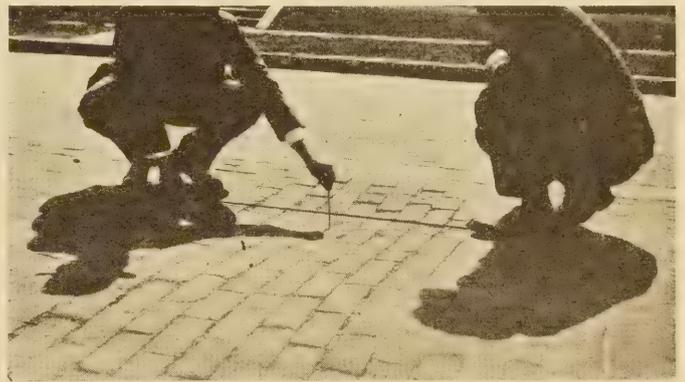
FIG. 20.—CONDITION OF $2\frac{1}{2}$ -INCH BRICK SURFACE LAID AT GREENVILLE, TEX., IN 1914, AS IT APPEARED IN FEBRUARY, 1926. DISPLACEMENT OF THE BRICK HAS OCCURRED OVER A BASE FAILURE WITHOUT BREAKING THE BRICK

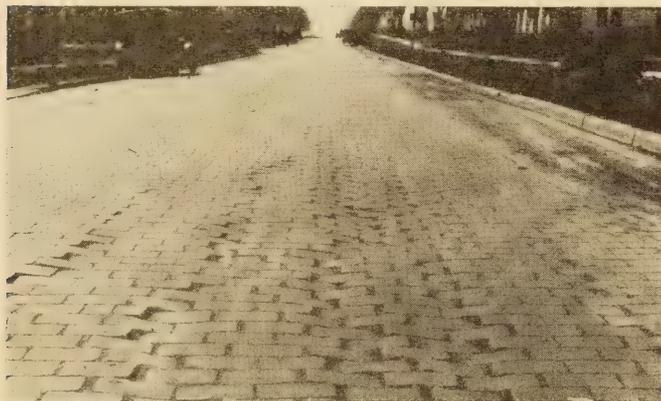
FIG. 21.—THE BASE FAILURE SHOWN IN THIS PHOTOGRAPH IS ON A RESIDENTIAL STREET OF TEMPLE, TEX. THE BRICK WERE LAID IN 1915 ON A 4-INCH CONCRETE BASE. THIS PAVEMENT IS IN THE BLACK WAXY SOIL AREA. NOTE THAT DISPLACEMENT OF THE BRICK HAS OCCURRED WITHOUT BREAKAGE

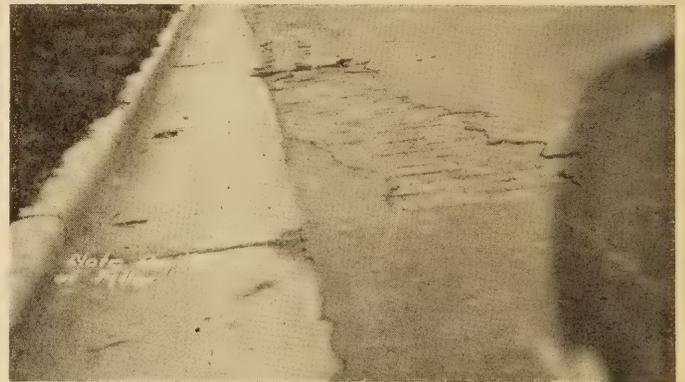
FIG. 22.—THE IMPORTANCE OF LIMITING THE QUANTITY OF ASPHALT FILLER TO THAT REQUIRED TO FILL THE SPACES BETWEEN THE BRICK IS ILLUSTRATED BY THE CONDITION OF THIS 2¼-INCH BRICK PAVEMENT IN TEXARKANA, TEX. THE PAVEMENT WAS LAID IN 1922

5. That the use of excessive quantities of asphalt filler is a common and serious fault in construction, unnecessarily increasing the cost and resulting in a condition which impairs both the appearance and the serviceability of the pavement.

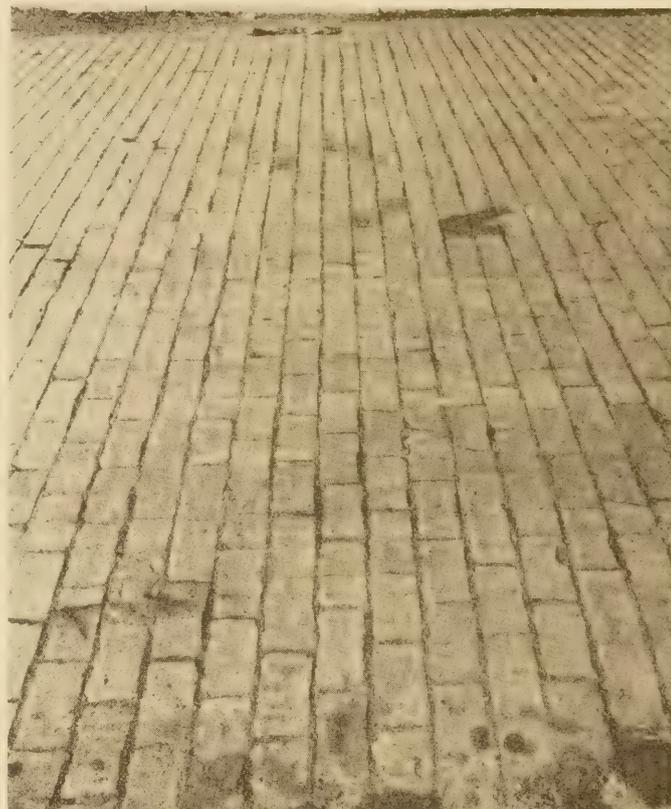
FIG. 23.—DETAIL VIEW OF 2½-INCH BRICK LAID ON PARKER STREET, OMAHA, IN 1915, DESCRIBED BY HERMAN BEAL. THE BRICK WERE LAID ON A 5-INCH CONCRETE BASE (1:3:6) WITH BITUMINOUS FILLER. THE PHOTOGRAPH SHOWS THE CONDITION OF THESE BRICK IN 1926 AFTER 11 YEARS UNDER MEDIUM TRAFFIC

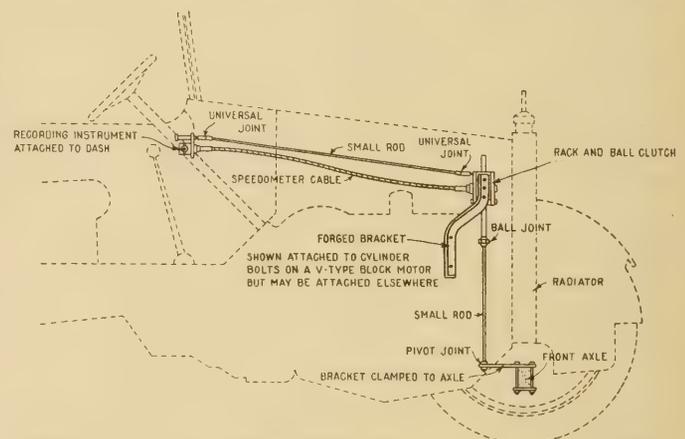
FIG. 1.—DIAGRAM OF THE RELATIVE ROUGHNESS DETERMINATOR MOUNTED ON AN AUTOMOBILE

Briefly, the roughometer consists of a rack which is attached in a vertical position to the front axle of the vehicle. Meshed with this rack is a spur gear which is supported by the frame of the car. Movement of the front axle with respect to the chassis, caused by deflection of the body springs, thus produces translation of the rack and rotation of the gear. This gear is connected through a flexible shaft to a mechanical counter on the instrument board of the automobile. Deflection

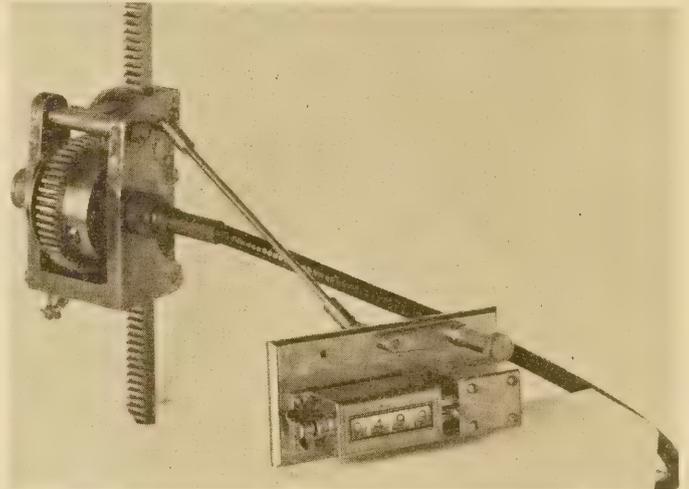
FIG. 2.—THE RACK AND BALL-CLUTCH MECHANISM AND THE RECORDING MECHANISM, COMPLETE BUT UNMOUNTED

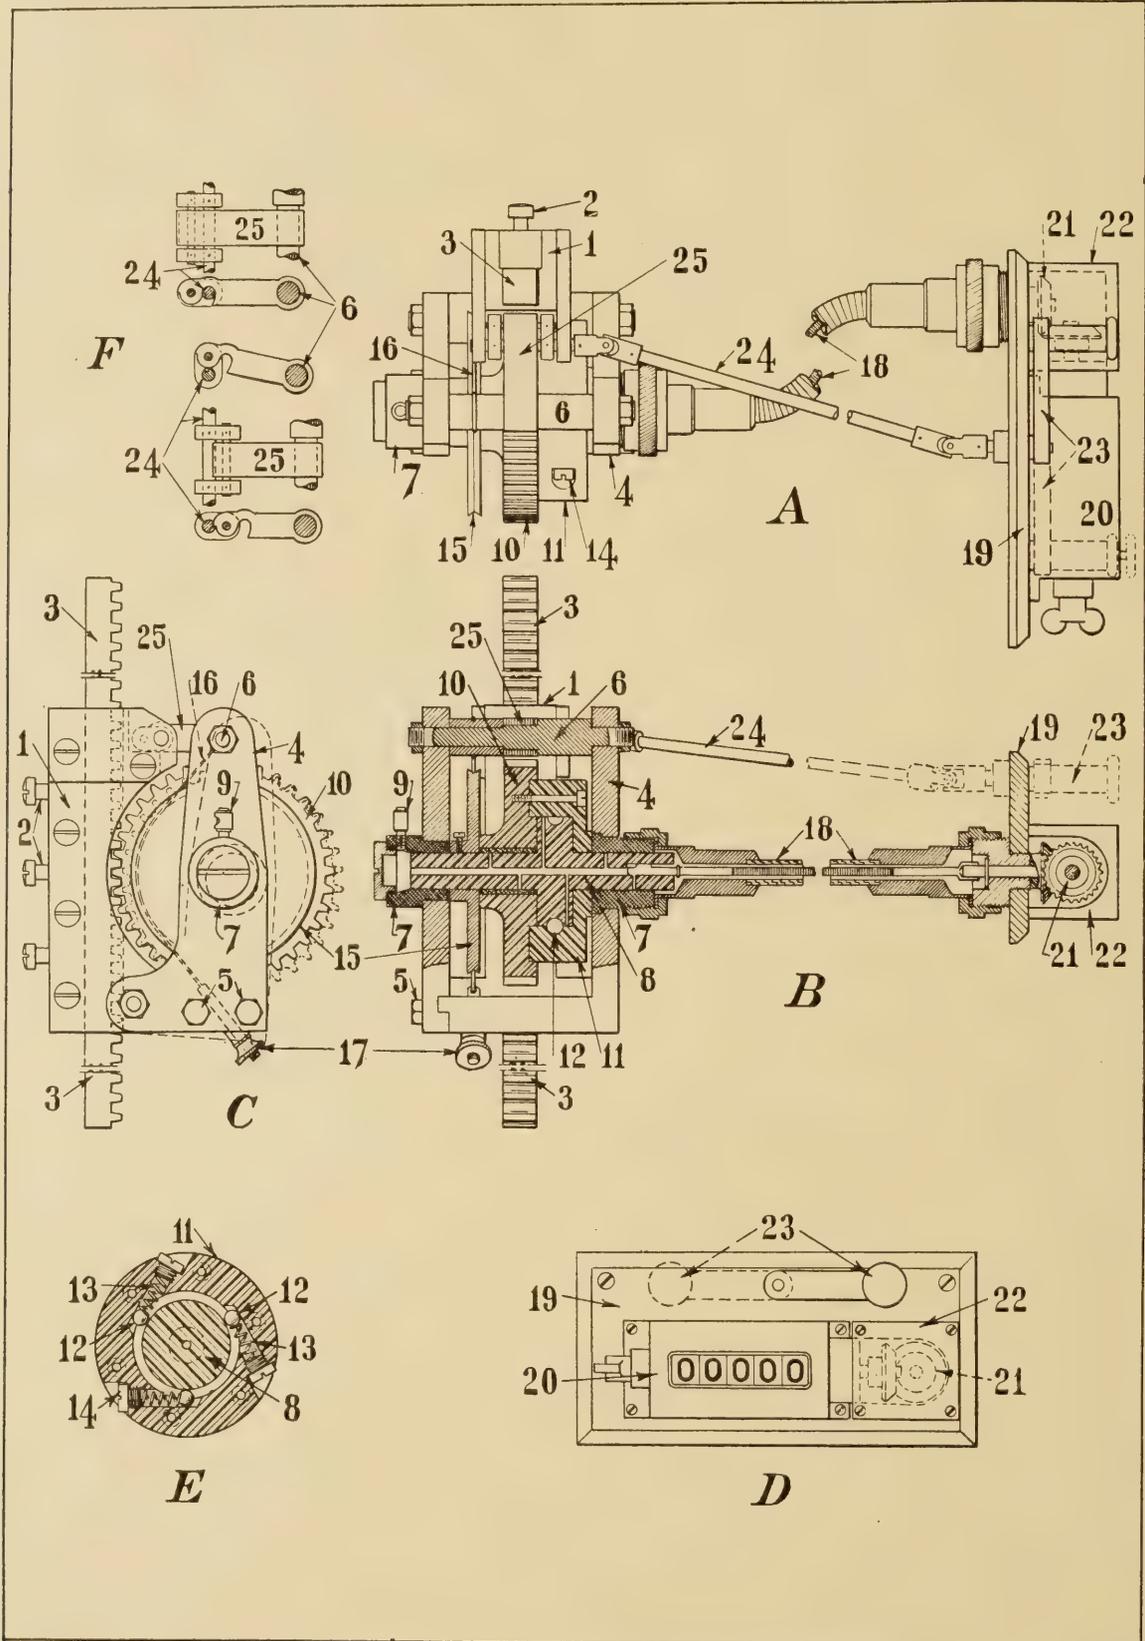
FIG. 3.—DETAILS OF THE RELATIVE ROUGHNESS DETERMINATOR

The various parts of the instrument are so designed that a movement of the rack of one inch records one unit on the counter. While it is possible to calibrate

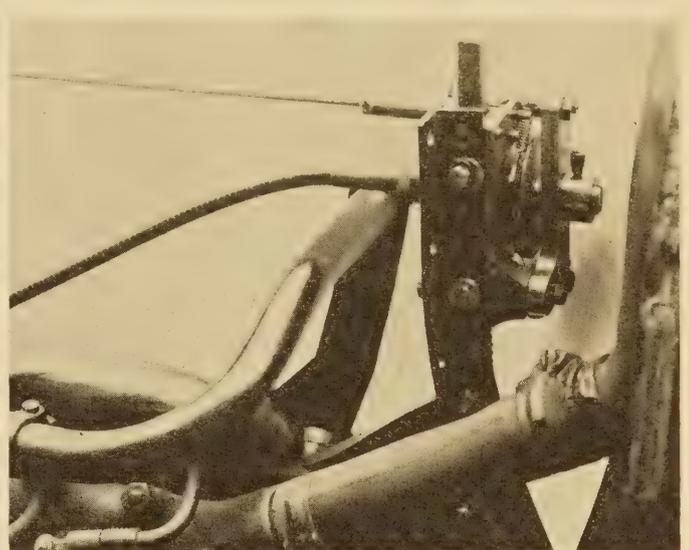
FIG. 5.—THE RACK AND BALL CLUTCH MOUNTED ON AN AUTOMOBILE

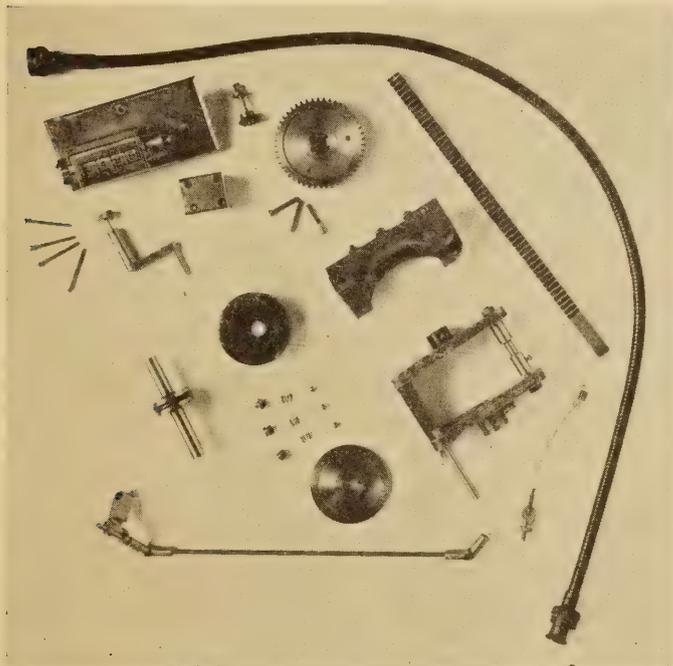
FIG. 4.—THE INSTRUMENT DISASSEMBLED, SHOWING SIMPLICITY OF THE VARIOUS PARTS

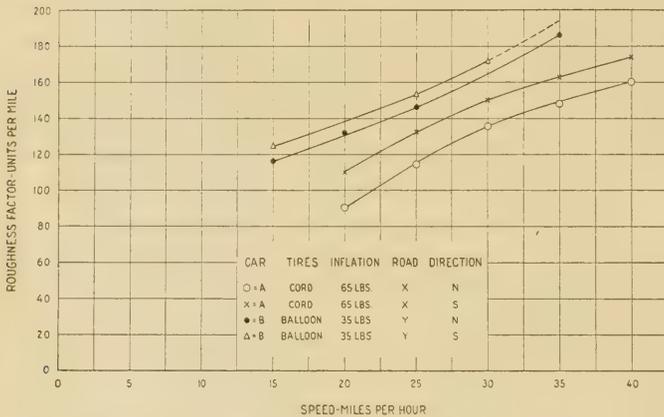
FIG. 6.—EFFECT OF VEHICLE SPEED ON THE ROUGHNESS FACTOR AS DETERMINED WITH TWO DIFFERENT CARS, ONE EQUIPPED WITH CORD TIRES AND ONE EQUIPPED WITH BALLOON TIRES

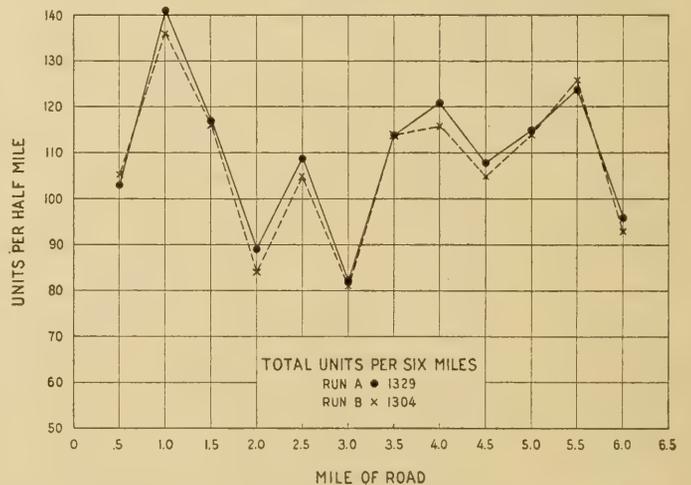
FIG. 7.—RESULTS OF TEST OF CONSISTENCY OF INSTRUMENT IN WHICH TWO RUNS WERE MADE IN THE SAME DIRECTION OVER THE SAME ROAD AT A SPEED OF 20 MILES PER HOUR. NO ATTEMPT WAS MADE TO FOLLOW THE SAME WHEEL PATH

Figure 7 shows graphically some data which indicate the consistency of the instrument. The car was driven
